# LUMINESCENCE IMAGING OF EXTENDED DEFECTS IN SiC VIA HYPERSPETRAL IMAGING

Over the past decade, improvements in silicon carbide growth and materials has led to the development of commercialized unipolar devices such as Schottky diodes and MOSFETs, however, much work remains to realizing the goal of wide-scale commercialization of both unipolar and bipolar devices such as pin diodes or IGBTs, for high applications requiring high powers, operating in elevated temperatures or radiation environments or for many fast switching applications. Despite the great strides that have been made in reducing extended and point defect densities during this period, such defects still remain and with the push to lower off-cut angle substrates are in many cases seeing increases in prevalence. Thus, spectroscopic and imaging techniques for locating and identifying these defects are in high demand. Luminescence imaging and spectroscopy have both been utilized heavily in such work, yet simultaneously obtaining corresponding spectroscopic and spatial information from such defects is problematic. Here we report on hyperspectral imaging of electroluminescence from SiC pin diodes, whereby a stack of lumine

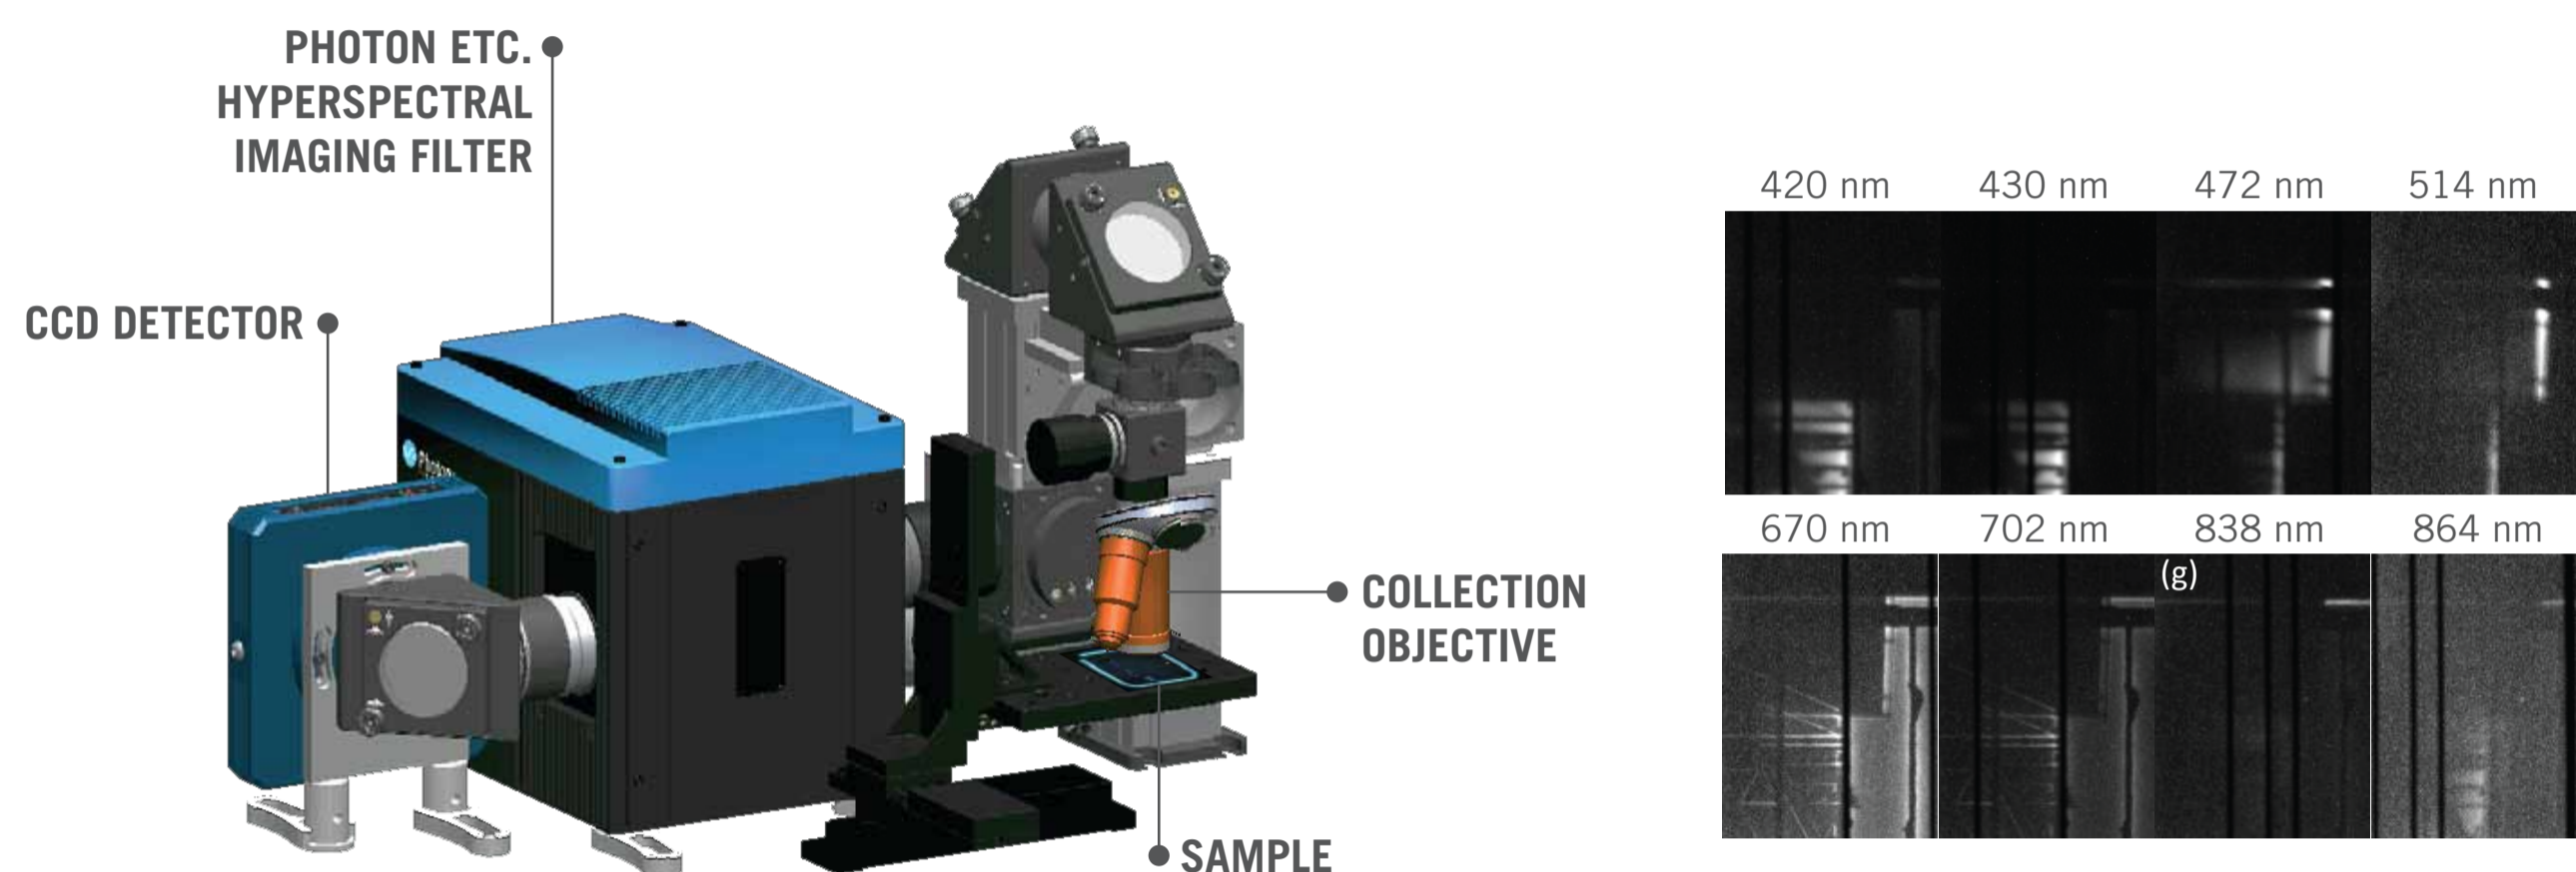
Electroluminescence (EL) was induced via driving  $\sim 28\text{A}/\text{cm}^2$  through  $0.93 \times 0.93$  mm pin diode. EL was collected  $20\times 0.4$  NA objective. A series of reflecting mirrors focused the EL onto the entrance slit of the hyperspectral imaging filter. By rotating the two volume Bragg gratings with respect to the incident, the output from the filter was narrowed to 2 nm, with the center wavelength of this pass-band varied from 400-900 nm. This output was focused onto a thermoelectrically cooled CCD detector. Images were collected in 2 nm increments for 30s each. The collection of images were stacked and a rectification process was performed that enables a spectrum from any given feature within the structure to be obtained, thereby providing direct correlation between given structural features and their corresponding spectra within a single acquisition set.

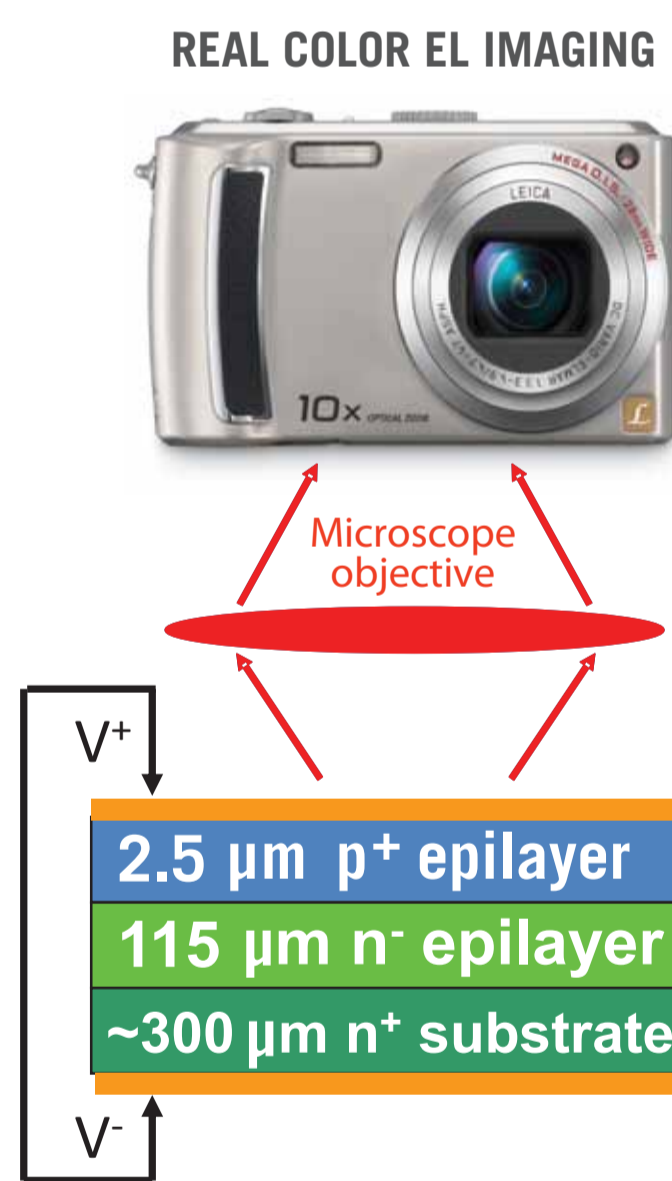
- Forward-bias injection of ehp induces EL
- EL Collected through  $10\times 0.25\text{NA}$ ,  $20\times 0.4$  NA and  $50\times 0.7$  NA objectives
- Imaging 1-10s Olympus 750 UltraZoom – ‘real-color’ imaging
